APPLICATION NOTE

Polymers – DSC 214 Polyma

Material and Failure Analysis of Plastic Parts by Means of DSC

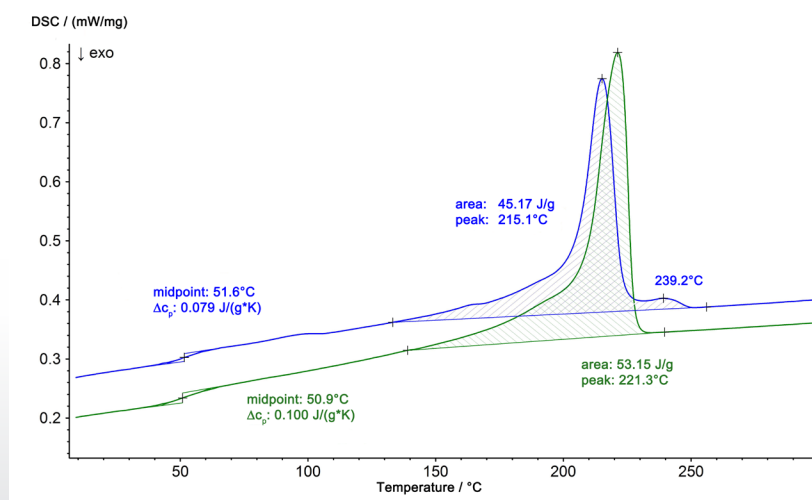
DSC analysis of the damaged part and an iO control part quickly identified the cause of the failure. The DSC curves are presented in figure 1. For analysis of the material composition, the 2nd heating curves are always evaluated since any effects of the thermal history are no longer present. Along with the glass transition of the sample at 50.9°C, the control part (green curve) showed a melting endotherm at 221°C with a melting enthalpy of 53.7 J/g (typical for pure PA 6). The niO part (damaged), however, showed measurably different behavior, with a peak temperature at 215°C and an enthalpy of 45.2 J/g.

1 DSC results of the 2nd heating of the iO part (green curve) and the niO part (blue curve)

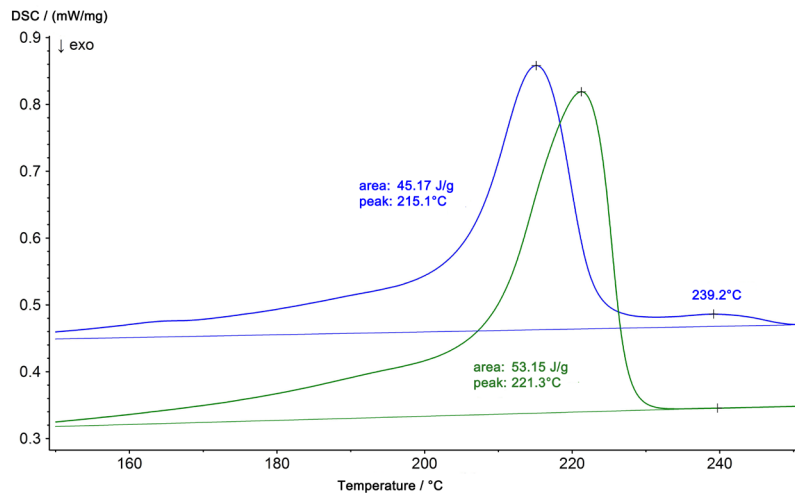
2 Enlarged scaling of the DSC results from figure 1

The melting profile of the niO part, shown on an enlarged scaling in figure 2, also shows a second peak at 239°C.

for the shift in the melting temperature from 221°C (pure PA 6) to 215°C (PA 6 + PA 66).

The results of the DSC measurements reveal that the material of the damaged part is no longer pure Polyamide 6 but, rather, a mixture of Polyamide 6 and Polyamide 66. These two components can form a eutectic, which accounts

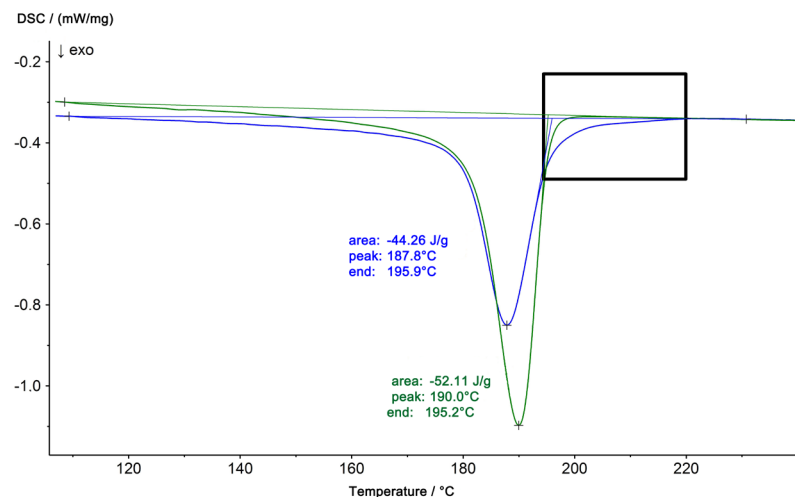
The differences between the two samples can also be seen from their different crystallization profiles during cooling (figure 3.)

3 DSC results of the cooling curves for the iO part (green curve) and the niO part (blue curve)

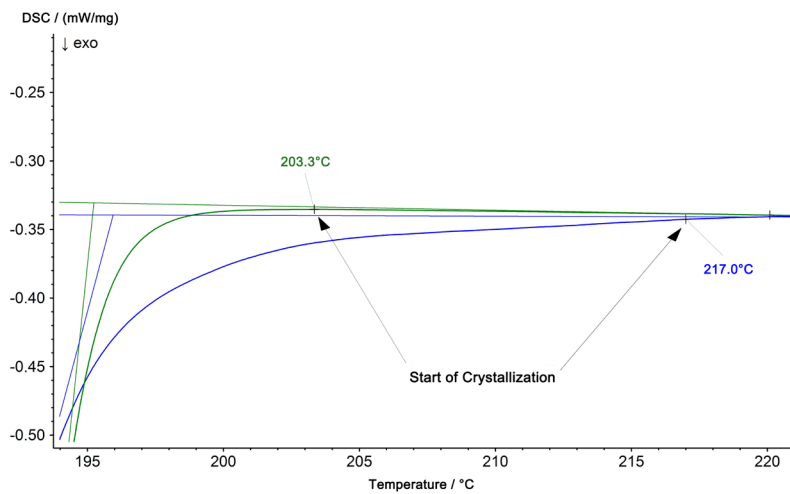
4 Enlarged scaling from figure 3

The enlarged scaling in figure 4 further shows a higher onset temperature for crystallization of the material from the iO part at 217°C, compared to 203°C for the pure PA6 sample. The area of the peak is also smaller for the iO part.
